R 731

Technical Report

SEAFLOOR FOUNDATIONS: ANALYSIS OF CASE

HISTORIES

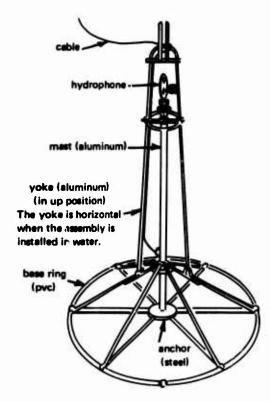
Figure 9. BARSTUR hydrophone assembly. (From NPOLA, 1969.)

BARSTUR has performed satisfactorily to date (Okura, 1969). Difficulties have been experienced with only two hydrophones. One hydrophone has become inoperative and will be replaced. A second hydrophone is experiencing a shadow effect which may possibly be caused by the proximity of a rock outcropping or ledge. Neither difficulty appears attributable to unsatisfactory foundation performance. Tracking is still good in the rest of the range; however, a shift of more than 20 feet would have been required before variations would be noticed. A detailed survey and inspection were planned for the fall of 1969, but have been postponed. Some difficulty has also been experienced with the hydrophone cables at the junction box (Good, 1970). During the winter storms of 1969-1970, several were torn loose from their bottom securing system (deadweight bags) and became entangled about the junction box (Black, Bruce, and Herrmann, 1970). Remedial steps were taken during the summer of 1970.

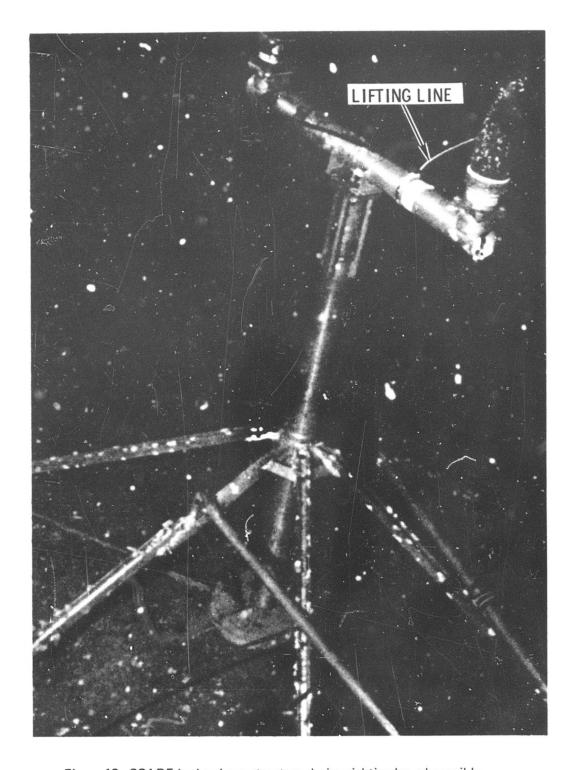
Figure 12. SCARF hydrophone structure during righting by submersible, DOWB. (From Momsen, 1970. Photo courtesy of AC Electronics.)

The structures were righted during the summer of 1969 using the DOWB (Figure 12). Output from the tracking hydrophones indicates that the foundations have performed satisfactorily since that time.

It is interesting to note that for all but one of the structures there was no obvious indication of improper orientation of the structures. The range inspection and subsequent remedial actions resulted in an overall improvement of the range effectiveness.

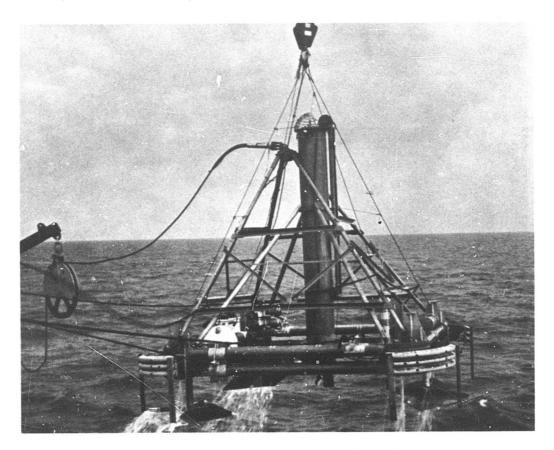
Figure 13. NCEL DOTIPOS.

DOTIPOS has a pyramidal frame with an 18-foot-square base and an overall height of approximately 16 feet. The platform is supported by three 4-foot-square pads. The total submerged weight varies from 1,900 to 4,000 pounds, depending upon the type of accessories attached. At maximum

submerged weight, the bearing pads apply a stress of 85 psf. Short-term settlements from 0.5 to 1.5 inches have been observed in soft cohesive sediments. No foundation performance difficulties have been experienced during more than 30 deployments on the seafloor in water depths to 5,600 feet.

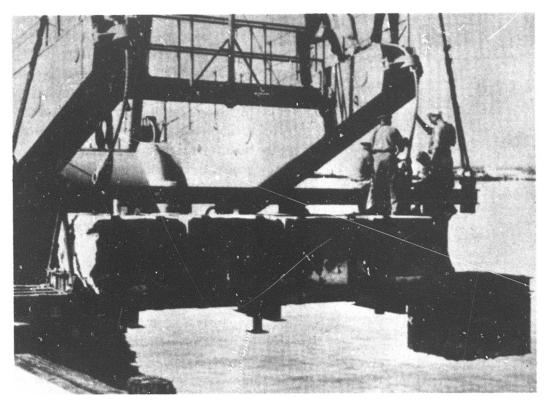
A load frame (Figure 15), which weighed 82,000 pounds in air and was estimated to weigh 48,000 pounds in water, supplied the reaction for each of the in-situ load tests. The frame had a bearing area of approximately 48 square feet (giving an applied stress of 1,000 psf). A 20,000-pound calibrated hydraulic jack on the frame was used to apply loads to the 12-, 19-, and 24-inch-diameter plates.

When the load frame was slowly placed on the seafloor, the frame settled 1-1/2 to 3 inches into the sediment at Site A and 1 inch at Site B. Once SCUE A divers had instrumented the frame, the plate bearing tests were performed. Values of ultimate in-situ bearing capacity as determined by this procedure were found to be generally higher (by factors of 2 to 3) than predicted by theory. The amount of settlement under a given stress increased as the plate diameter increased, as predicted by existing terrestrial theory.

Figure 15. Load frame for ESSA plate bearing tests. Top: drawing and specifications. Bottom: photograph of frame being transferred (by crane) from wharf to suspension cables of U.S.S. Salvager. (From Harrison and Richardson, 1967. ©University of Illinois Press. Used by permission.)

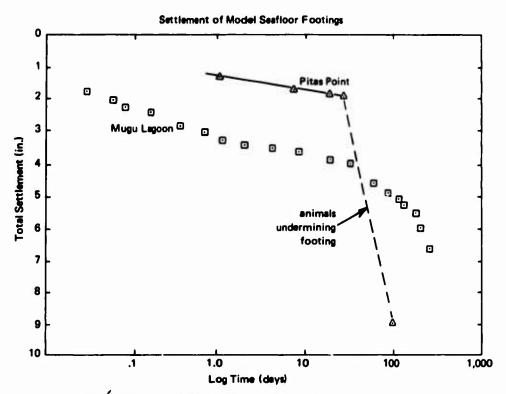
Figure 17. Typical settlement data from LOBSTER tests.

7 inches of settlement caused by scour was accompanied by a tilting of about 20 degrees. This tilting is equivalent to a differential settlement of about 18 inches. A more typical value of differential settlement, resulting from primary and secondary compression only, was 1 inch.

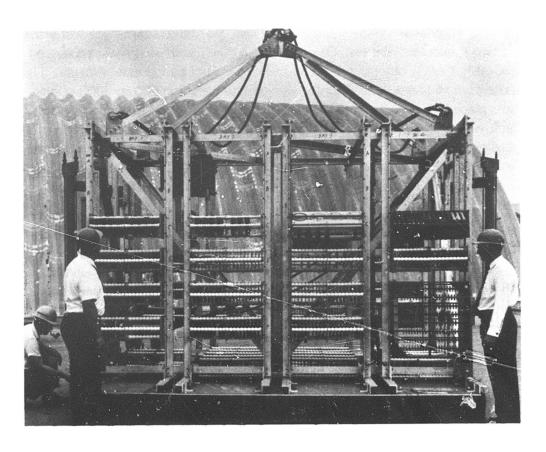
Figure 19. NCEL STU.

In most cases, the STUs were supported by two strip footings. The footings applied approximately 110 psf to the sediments. Sediments generally varied between silty clays and clayey silts. The soil at the shallow-water location was predominantly sand size.

Estimates of total settlement were determined from mudline markings on test specimens. Total penetration values varied between negligible and 8 inches. No distinctions could be made between dynamic, immediate, and long-term settlement processes.

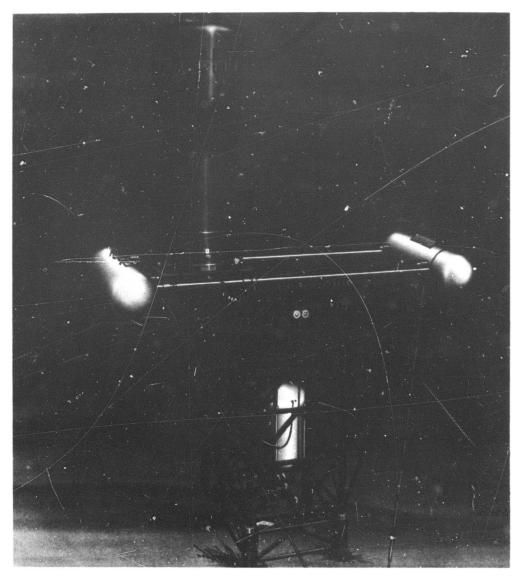
Figure 20. NUC's Pop-Up Launcher II. (From Gardner et al., 1969.)

In 1960, a more complex launch system (Figure 20) was installed in 170 feet of water at a nearby site. The soil profile was essentially the same. This system had a static weight of over 700,000 pounds and resisted dynamic compression loads of up to 220,000 pounds during individual tests. The test structure was supported on four 14-inch-diameter by 65-foot-long drilled-in, grout-filled, pipe piles. Over 200 simulated launchings have been performed. Although no foundation monitoring was provided, it is known that the threshold sensitivity of other electronic equipment mounted on the structure (differential movement of less than 1/8 inch) was not exceeded.

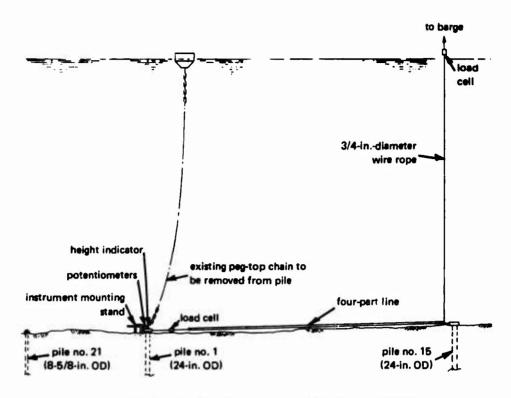
Twenty-one mooring piles were also installed in the seafloor surrounding the pop-up launchers. These 24-inch-diameter by 36-foot-long, drilled-in, grout-filled, pipe piles are similar to those used for the camera support. One of the mooring piles was tested in 1964 to evaluate its lateral load capability. Figures 21 and 22 show the in-situ test setup. A lateral load of 50,000 pounds caused a maximum deflection of 1/2 inch and maximum angle of deflection of 25 minutes.

Figure 21. Pop-Up Site pile load test. (After Sutton, 1969.)
